Manhole Inspection Summary

Manhole # S49II_037MH

Insp Date: **5/14/08 8:07 AM**

Location Address: **Oliver**

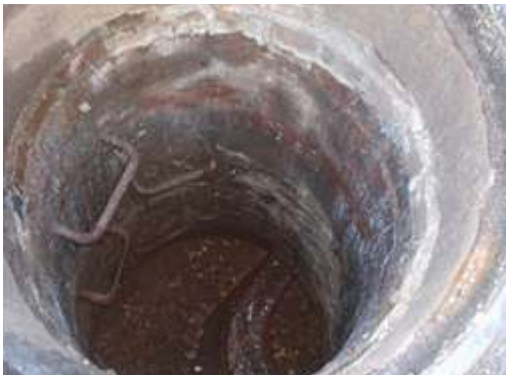
Defect 2

frame leaks

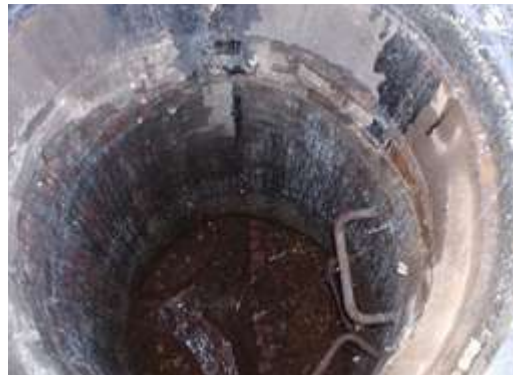
Defect 1

Infiltration: ☐ None ☒ **Joint** ☐ Cracks ☒ **Mortar** ☐ Roots ☐ Wall

Infiltration

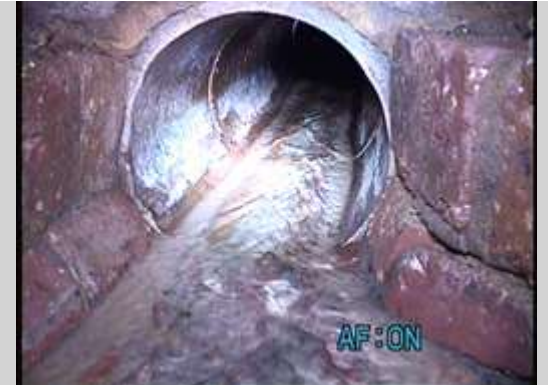
12 O'Clock Outflow

8 in. Circular Gravity Sewer
Pipe Out @ 12 O'Clock

Pipe Height: **8.4** (in.) Rod and Bar (Angled)
Pipe Material: **Clay** ☐ Pipe Lined
Invert Depth: **9.80** (ft.) Flow Characteristics: **Fast**
Deposits: ☒ None ☐ Mud ☐ Sludge ☐ Debris ☐ Grease
Silt Depth: (in.) Deposits Extent:
Infiltration: **None** Pipe Seal Cond: **Sound**

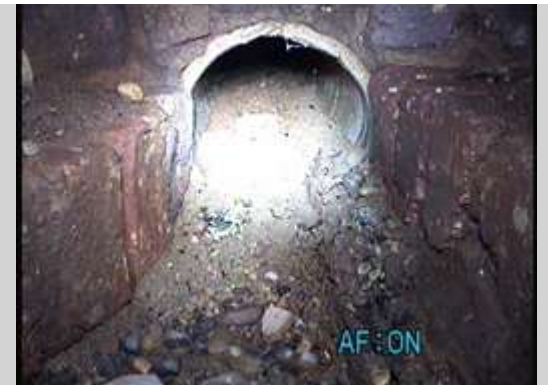
3 O'Clock Inflow

6 in. Circular Gravity Sewer
Pipe In @ 3 O'Clock

Pipe Height: **6** (in.) Rod and Bar (Angled)
Pipe Material: **Clay** ☐ Pipe Lined
Invert Depth: **9.40** (ft.) Flow Characteristics: **None**
Deposits: ☒ None ☐ Mud ☐ Sludge ☐ Debris ☐ Grease
Silt Depth: (in.) Deposits Extent:
Infiltration: **None** Pipe Seal Cond: **Sound**

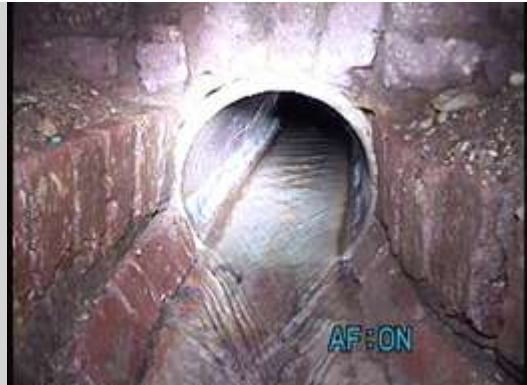
9 O'Clock Inflow

8 in. Circular Gravity Sewer

Pipe In @ 9 O'Clock

Infiltration: **None** Pipe Seal Cond: **Sound**
